# Residential inspection report

Underground household water-supply pipe | Anonymised completed case

| PUBLIC SAMPLE REFERENCE | LPP-PUBLIC-RES-20261002 |
| SYSTEM | Residential water-supply pipe |

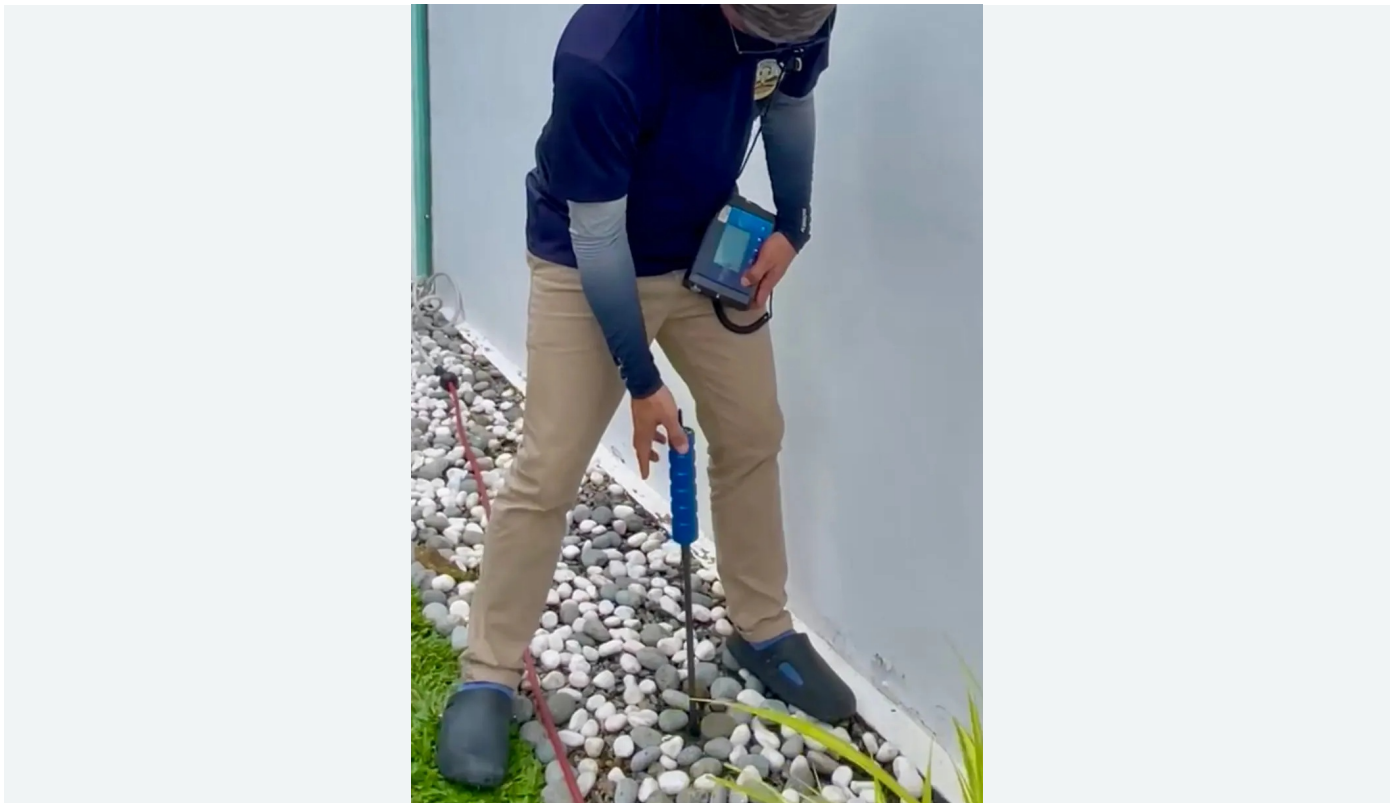
Photo A. Focused ground listening along the residential supply route. Cropped from the actual case photograph to limit wider property details.

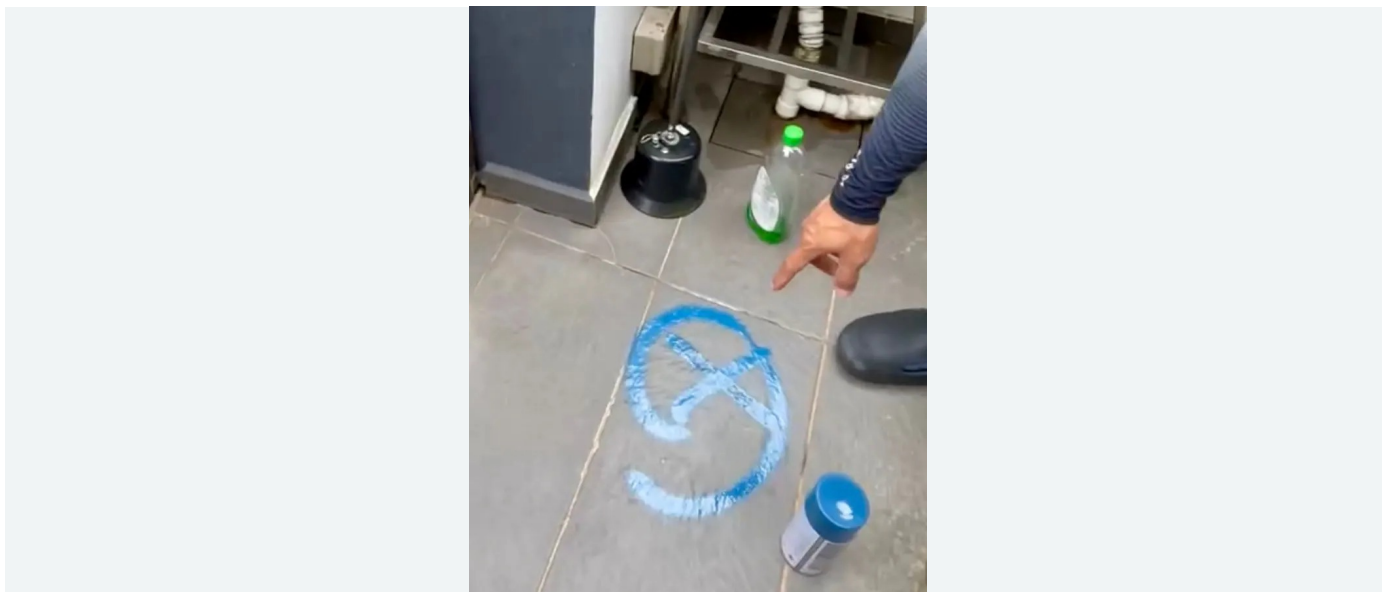
A surface mark was placed after acoustic comparison to guide the appointed plumber. The mark was a practical starting point for excavation and did not guarantee the exact defect position.

Photo B. Blue surface marking in the investigated area. Actual case photograph.

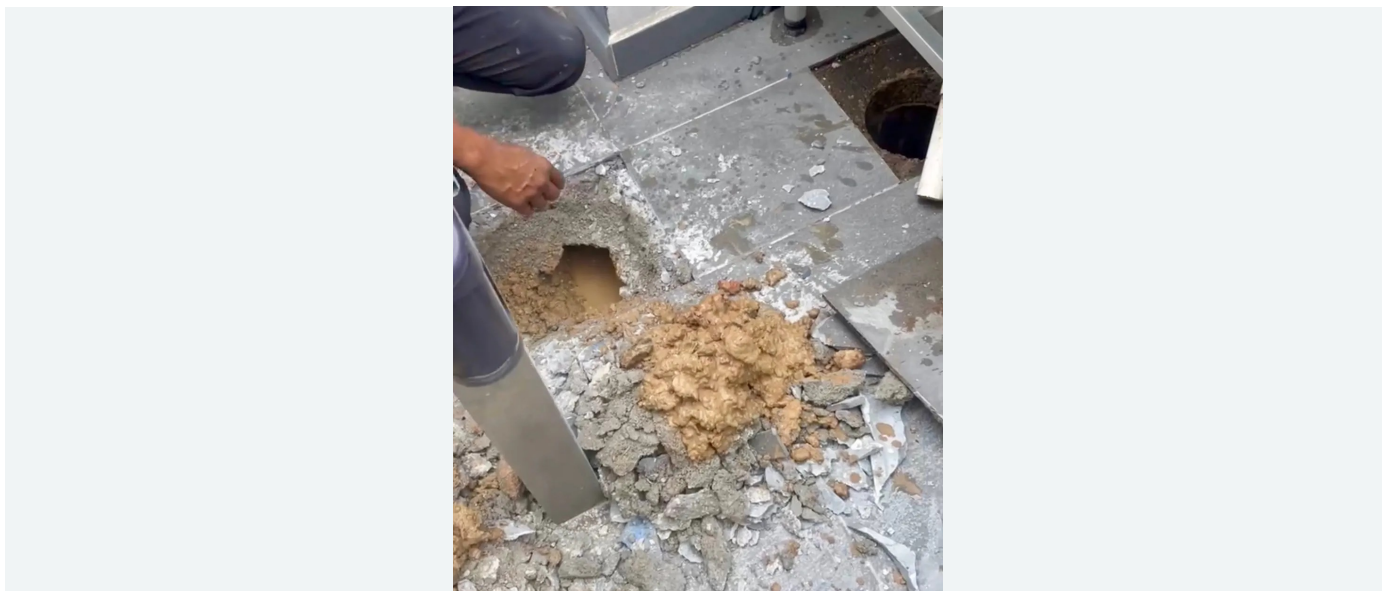
Photo C. Controlled excavation by the customer-appointed plumber. The case record states that the relevant pipe was exposed and a defect repaired; this photograph alone does not establish the defect type.

The customer-appointed plumber exposed the HDPE pipe near the marked area and carried out repair and reinstatement. After repair, the owner reported that the water meter returned to normal behaviour. This post-repair result is customer-reported; this sample does not claim an independent post-repair meter test by LeakPinpoint.
